Smith College Campus ADA Accessibility Report

By Lily Gould, Olivia Kraft, Allison Pasbjerg, and Mia Schildbach
Community Partner Project in Collaboration with the Smith College Botanic Garden

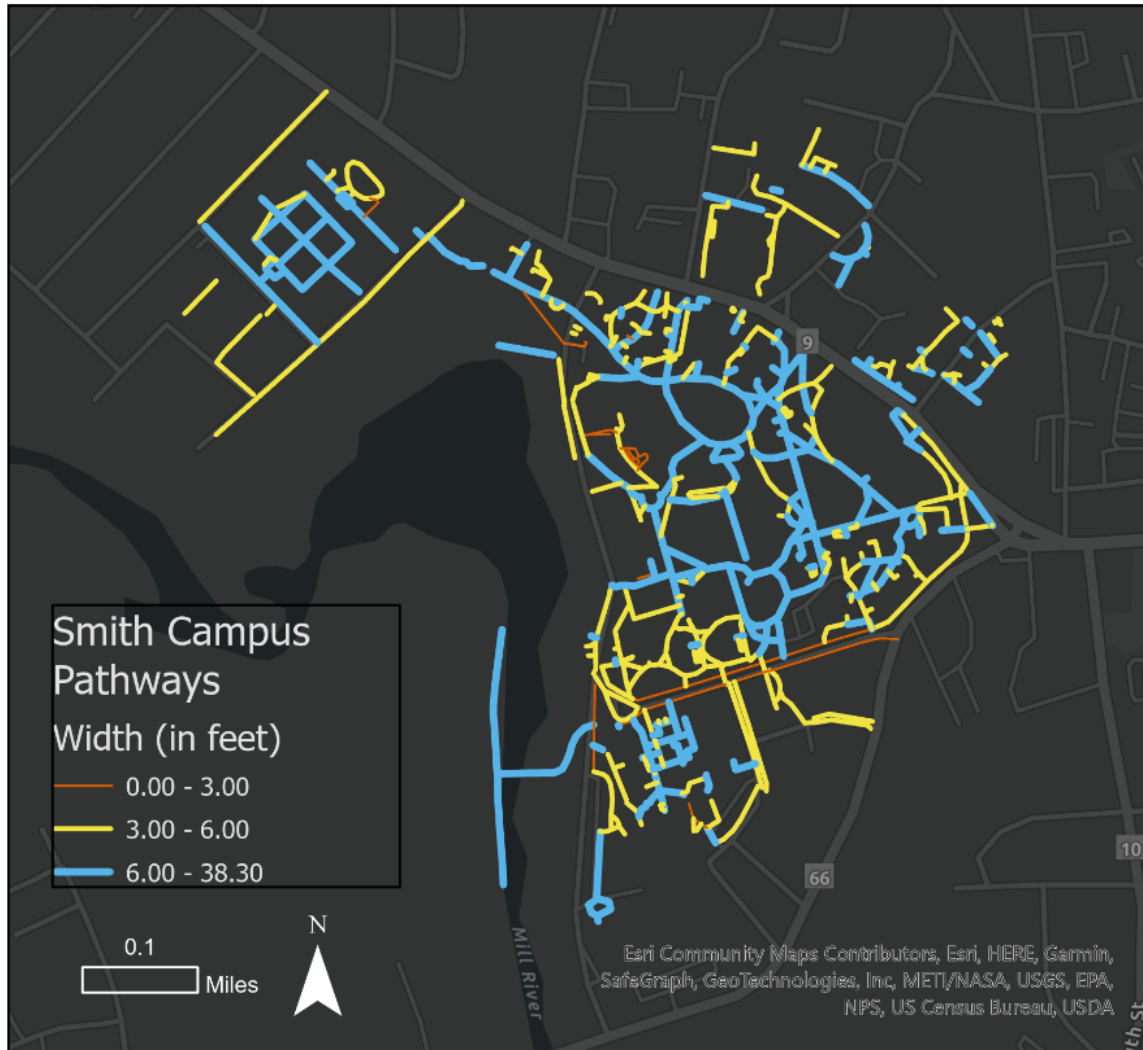
Figure 5: A map displaying width of paths around campus. The paths colored in orange are those that do not comply with the ADA restriction of >3 feet. Path width is shown additionally with the line weight, with blue paths being the widest, yellow being mid-range, and orange being the thinnest and inaccessible routes.

Of the 350 paths we collected data on, there were 8 that did not comply with the ADA restrictions. These inaccessible paths are colored in orange (**Figure 5**). The rest of the paths can be considered accessible on the basis of path width.

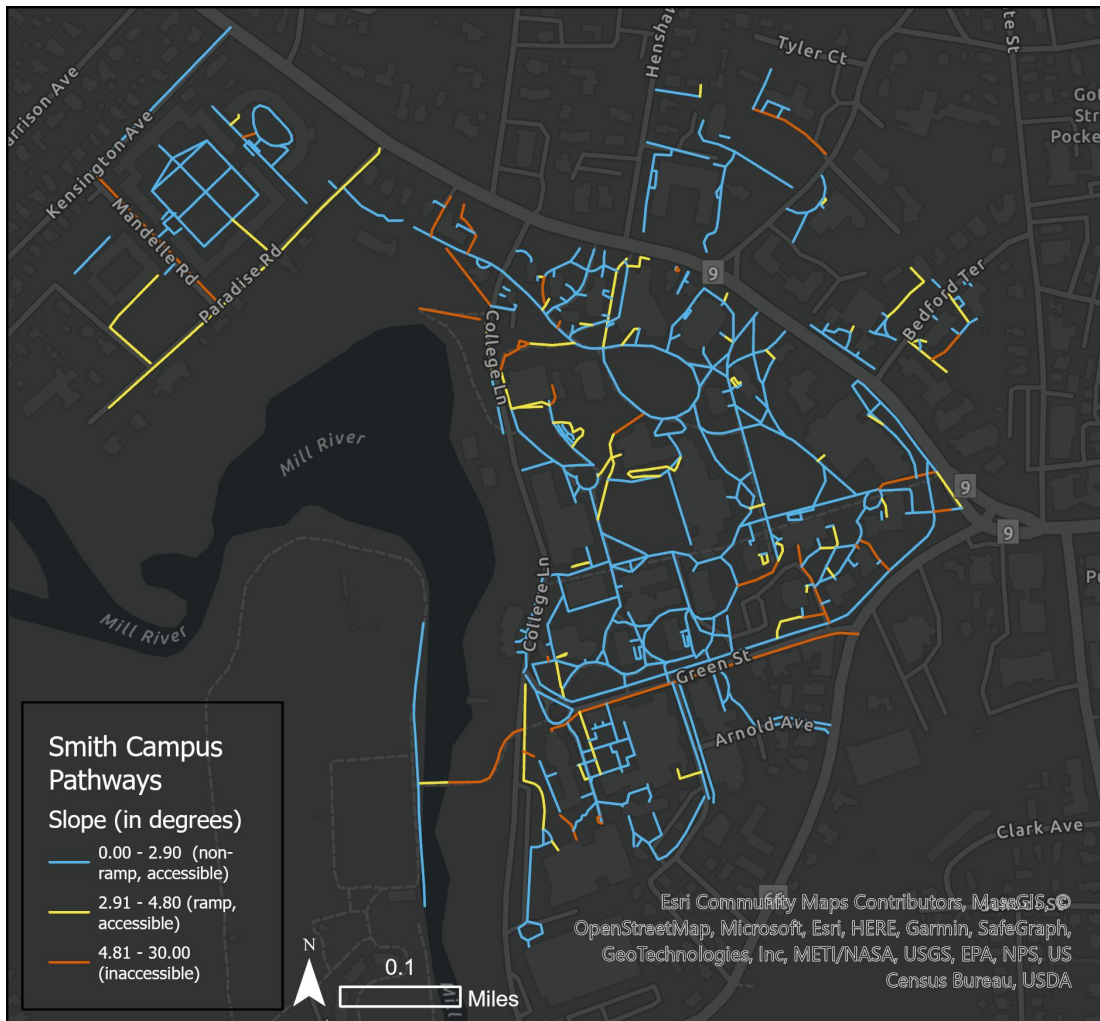
Figure 6: A map displaying slopes of paths around campus. Blue and yellow paths are both considered accessible slopes under the ADA, but orange slopes are too steep to be accessible under the ADA.

According to ADA standards, ramps and curb ramps are required for accessible routes spanning changes greater than ½ inch. Additionally, if portions of accessible routes have a slope greater than 5%, they are also required to be treated as ramps ([U.S. Access Board, ADA §405](#)). As seen in **Figure 6**, we grouped paths with slopes between 2.91 and 4.8 degrees as paths that would be considered ramps. As such, these paths under ADA standards are required to have railings. There were 29 ramps with no railings, 12 ramps with partial railings, and 9 paths with railings along the whole path. Without railings, many of these sloped paths become inaccessible. Most paths (256 out of 350) were considered non-ramps and accessible based on slope. There were 29 paths considered inaccessible based on slope.

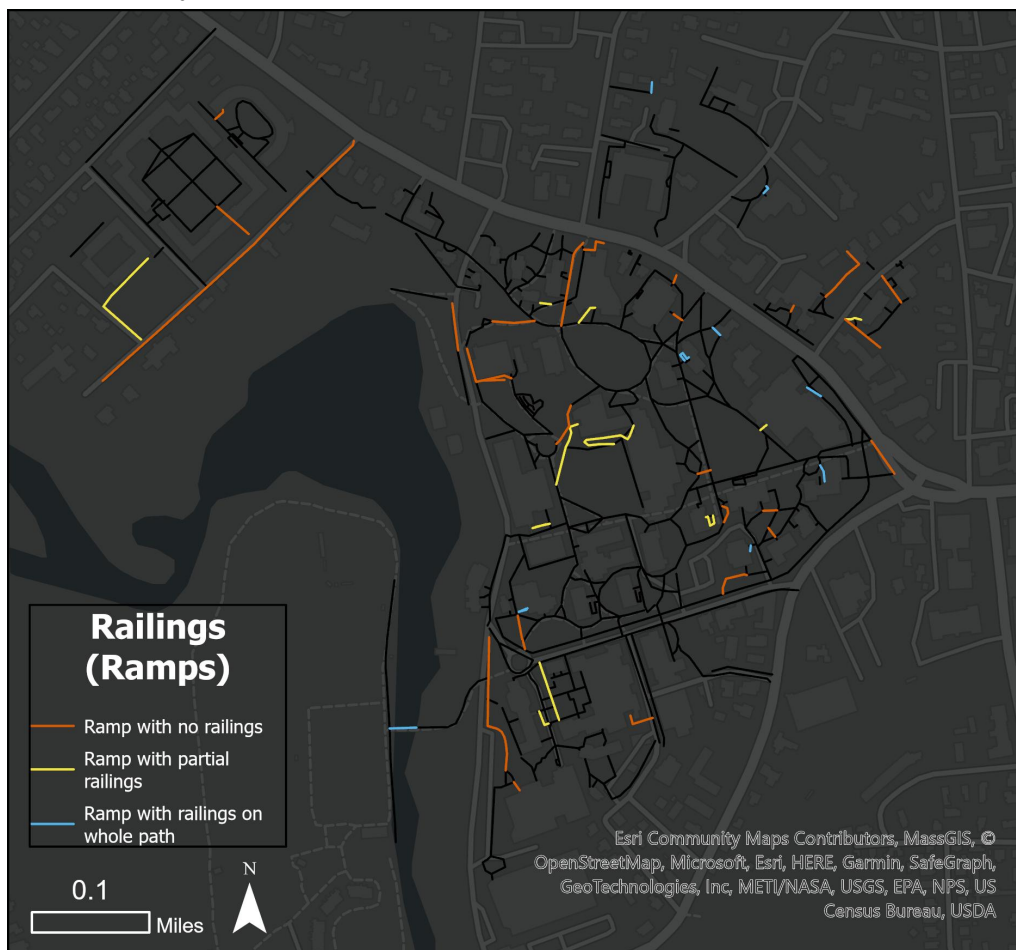
Figure 7: A map displaying paths considered to be ramps under ADA slope standards, with ramps with no railings in orange, ramps with partial railings in yellow, and ramps with full path railings in blue.

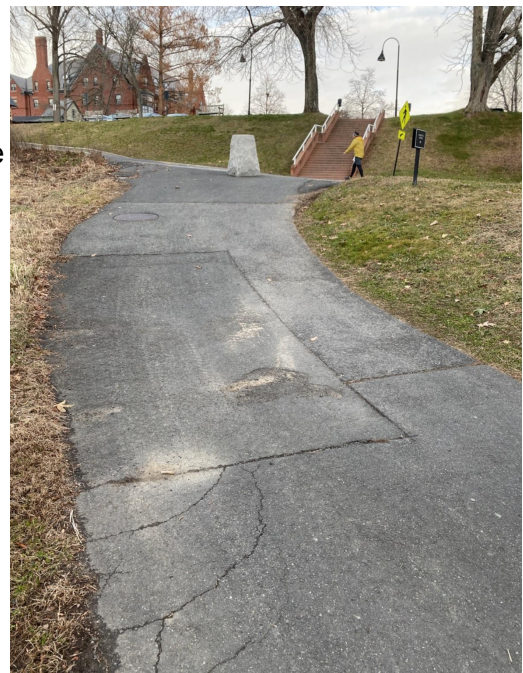
Figure 9 (right): An image of the path leading down to the athletics field. This path is a problem because it both has a slope of 9.8 degrees, way above an accessible measurement, and it lacks a railing.

Also important to consider is the priority level for railings versus addressing extreme slopes on campus. For very steep slopes, there first needs to be a more accessible alternative before making side railings. If the slope is too steep, adding side railings won't make the path more accessible.

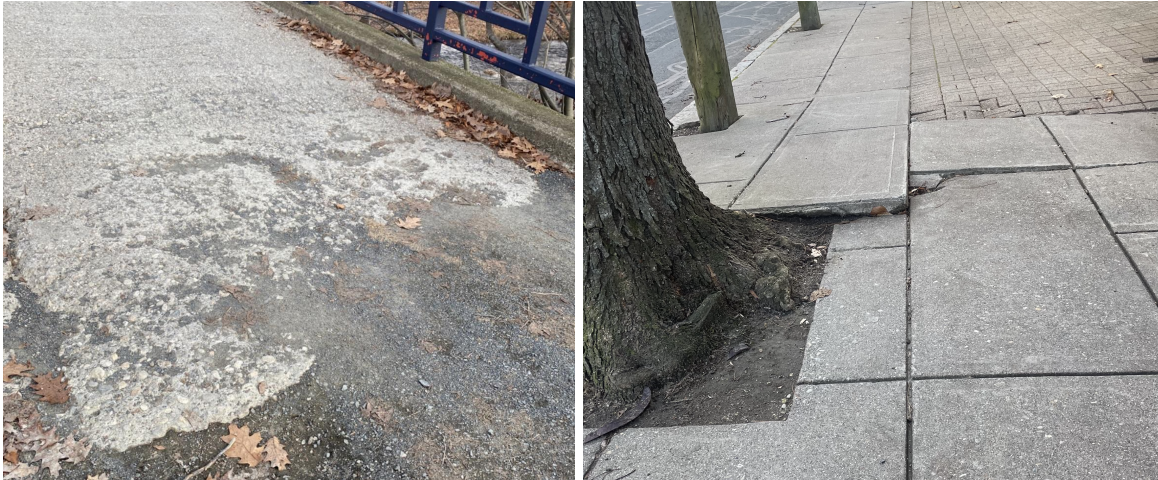
Given that the majority of campus paths are outdoors and thus entirely unprotected from weather conditions, there is undeniably the possibility of problems arising due to wear-and-tear. Some of the most notable problems that can arise from this are cracking and potholes, which can make an otherwise accessible material (such as asphalt or concrete) inaccessible by making it no longer flat (See **Figure 10**).

Figure 10: Examples of weathering that is problematic for accessibility. Left: Potholes on the bridge to the Smith athletic fields. Right: Uneven sidewalk outside of the Smith bookstore.

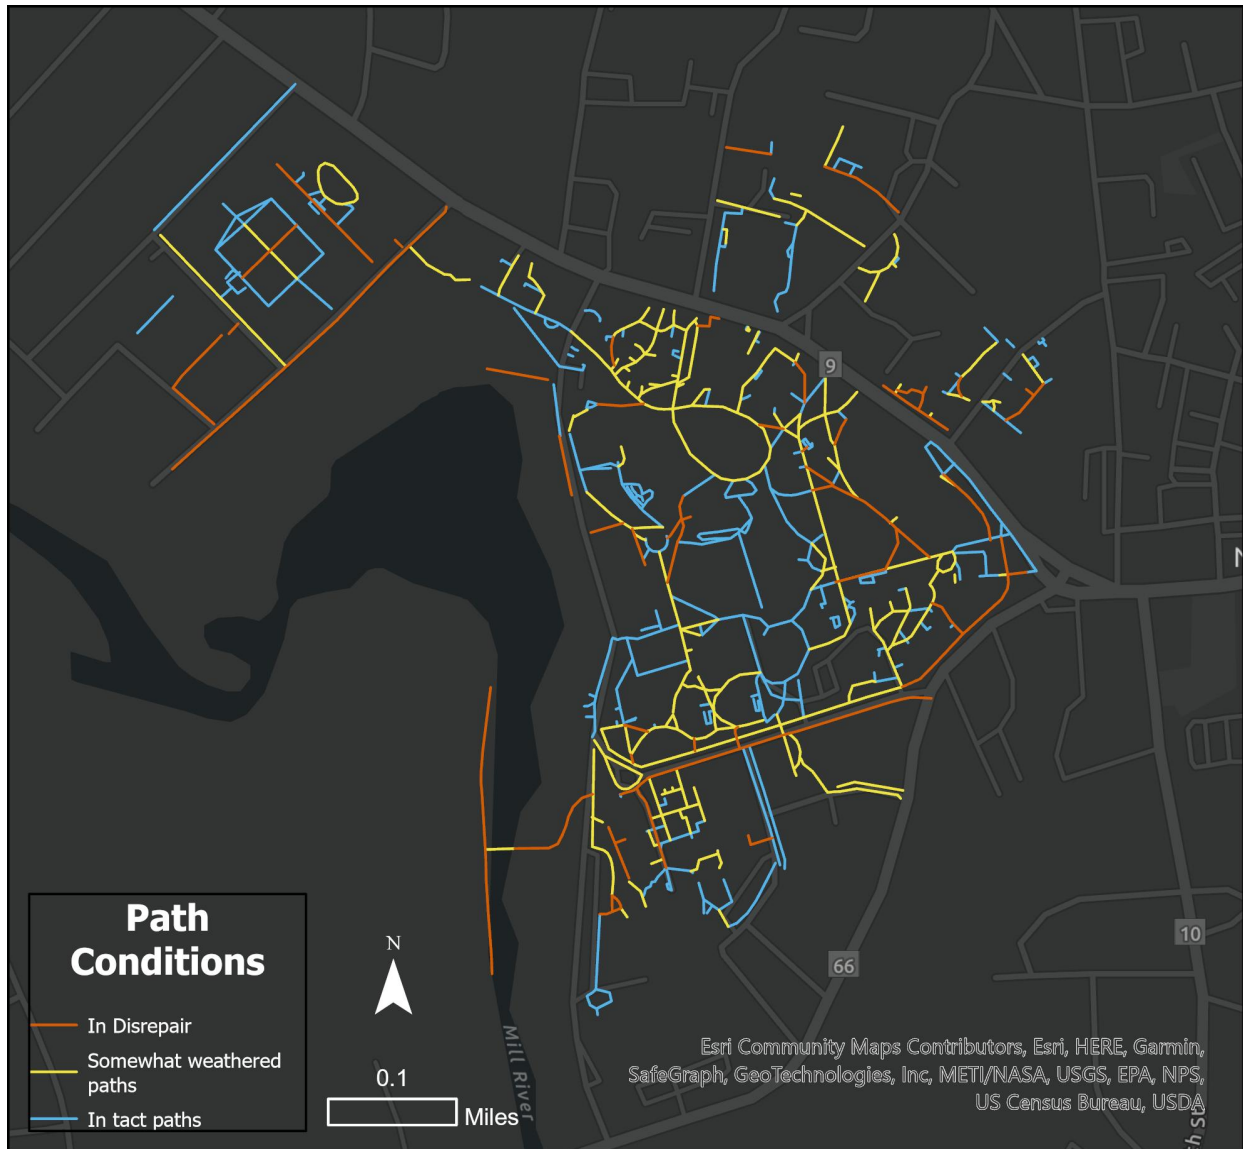
Figure 11: A map displaying the weathering conditions of the paths around campus. The paths displayed in orange, labeled as “In Disrepair” on the map legend, are the ones weathered severely enough to pose an accessibility issue.

Of the 350 paths for which data was taken, 49 were considered “In Disrepair”—that is, weathered severely enough that the paths were no longer ADA compliant. Of the remaining paths, only 183 were fully intact, with the remaining 118 still being noticeably weathered (though not to the point that it was actively hindering accessibility).

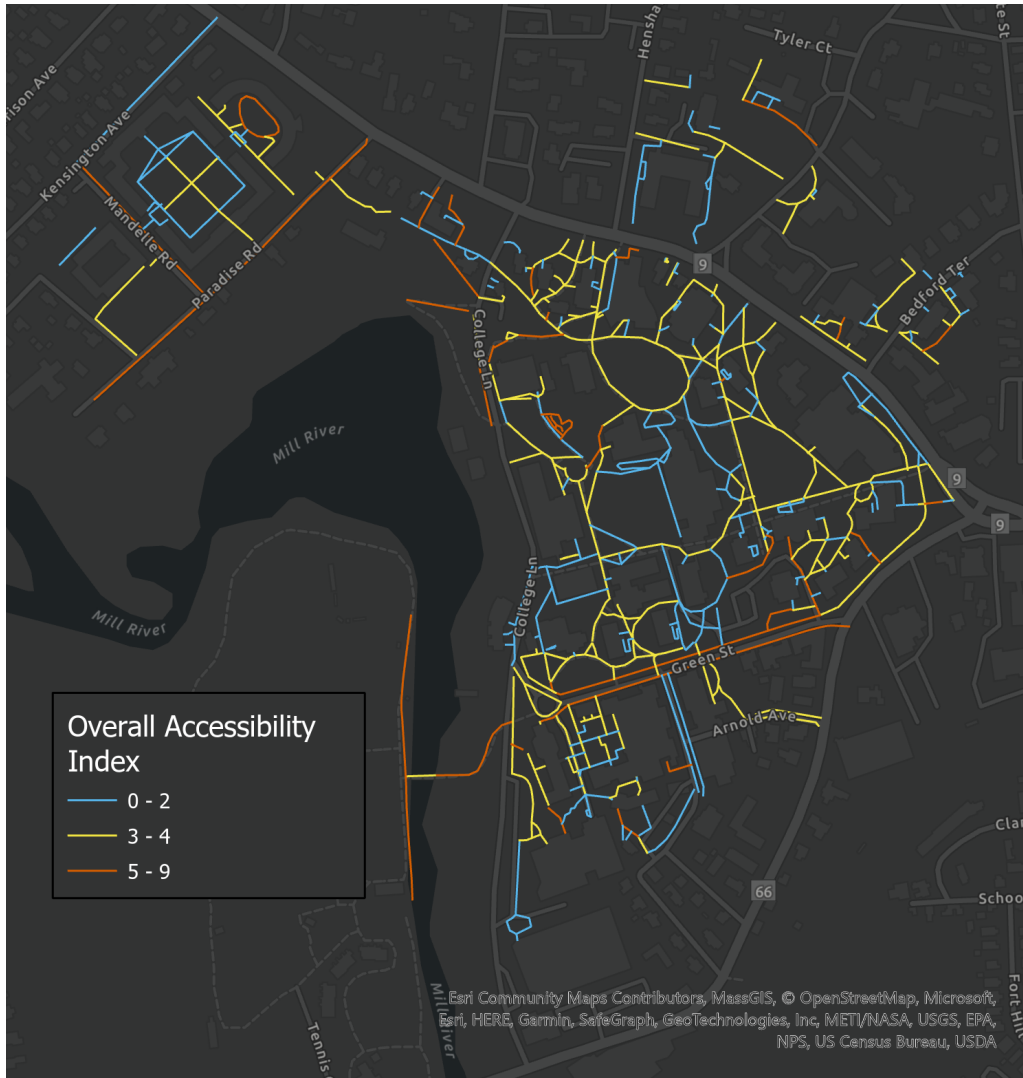
Figure 13: A map of the overall accessibility index for the various paths on campus, with values of 0-2 displayed in blue, values of 3-4 displayed in yellow, and values of 5-9 displayed in orange. Notably, there is a lot of yellow present throughout the different areas of campus.

Because the calculation here was done relatively simply, there is a degree of ambiguity present in the overall calculated values. For example, one would assume that an accessibility index value of any number above 0 would always mean there is an accessibility issue when this is not necessarily the case—for example, a non-ramp path that is otherwise fully accessible would still have a score of 2 if it had no side railings, even if it was flat enough that railings would not be needed following ADA standards. To account for this, **Figure 13** groups paths with a value of 0-2 together in the lowest category. Following similar logic, one can assume that paths with an index value of 3-4 likely have at least one major accessibility issue (or possibly two minor ones), since each additional issue recorded would add a value of 1 or 2 to the score. Finally, any path with a score above 4 likely has several accessibility issues, so these are also grouped together in the map above, as they should likely all be treated as the highest priority in terms of refurbishment/redesigning.
