COASTAL EFFECTS OF HURRICANE FLOYD ON
SAN SALVADOR ISLAND, BAHAMAS

H. Allen Curran, Priscilla Delano, Brian White, and Meredith Barrett
Department of Geology
Smith College
Northampton, Massachusetts 01063

ABSTRACT

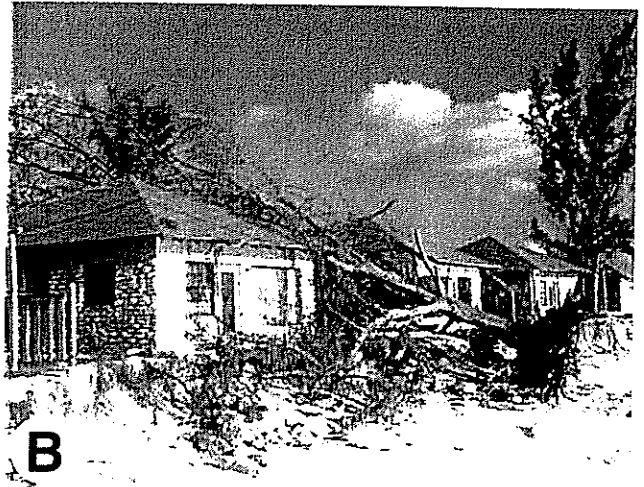
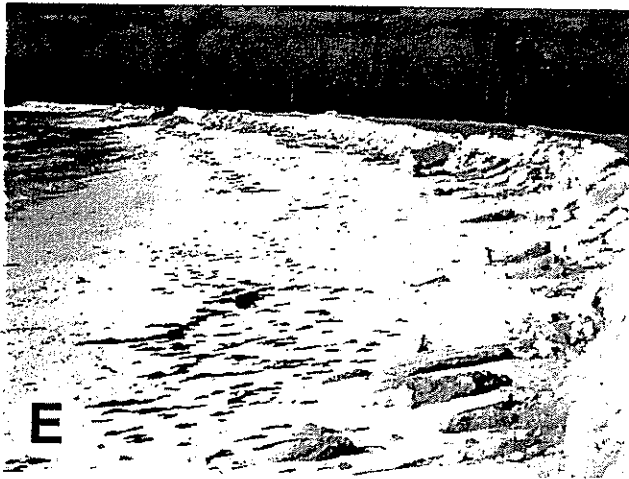
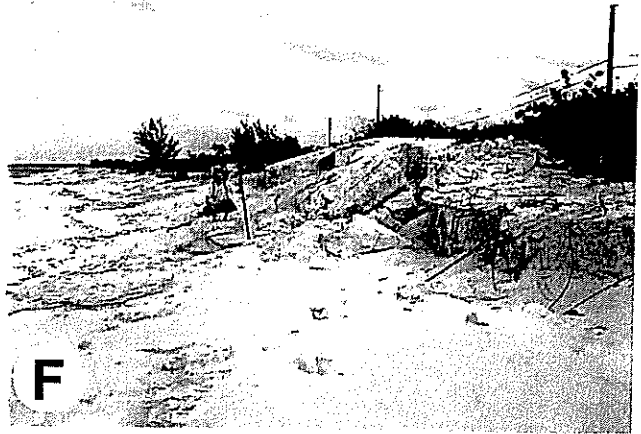
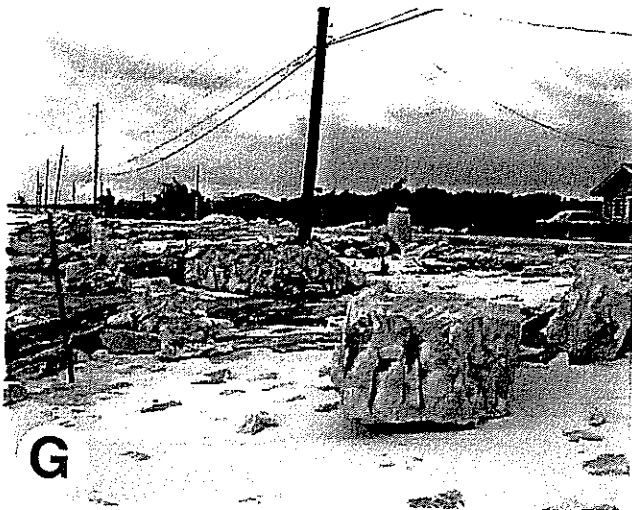
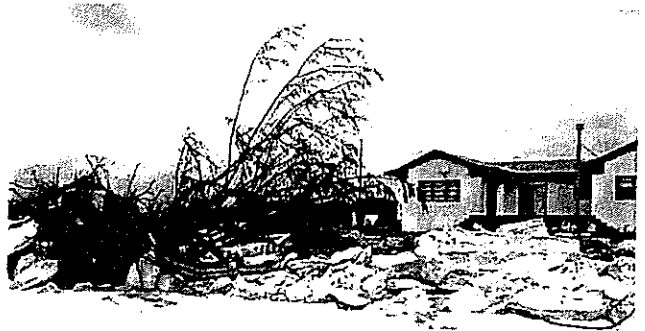
fresh outcrop surfaces (Fig. 4A). Walker et al. (this volume) documented many of the storm's effects in this area.

As reported by Gamble et al. (2000), the Riding Rock Inn received the most severe damage of the three tourism facilities that they surveyed. In January 2000, much damage was still in evidence here (Fig. 4B), and the back of the narrow beach was severely scarped, with the beach littered by boulders, rock rubble, downed trees, and vegetation debris.

→ *Figure 4. Storm erosion effects and damage in Area 2 - Rocky Point to Fernandez Bay: A) Much rock rubble littered the Cockburn Town Fossil Reef site and fresh exposure surfaces were numerous. B) Damage to Riding Rock Inn cottage units was severe, as seen in January 2000. C) An old, abandoned building in Cockburn Town, immediately adjacent to the shore, was extensively damaged. D) Jumbled grave sites in the cemetery immediately south of Cockburn Town. E) View looking north along the Queen's Highway bordering Fernandez Bay; the south end of the seawall is at the top left of the photo. All along this area, the base of the road was severely eroded, with the top of the road about 1.5 m above the beach. Note the highly scoured appearance of the beach. F) A low but continuous scarp was cut in sandy beach areas at the south end of Fernandez Bay. G & H) Extensive beach scouring and vegetation damage was present in the developed areas at the south end of Fernandez Bay.*

Damage to buildings in Cockburn Town proper also was extensive (Gamble et al., 2000). The town dock was largely destroyed and several of the older, abandoned buildings immediately adjacent to the coast were severely damaged (Fig. 4C). The cemetery immediately south of the center of Cockburn Town also was extensively eroded and damaged (Fig. 4D).

wall and road, with development of a scarp of up to 1.5 m in height (Fig. 4E). At the southern end of Fernandez Bay, beyond the reach of the seawall and toward the Columbus Monument park area, severe scarping of the back of the beach continued to be the norm. Rock rubble was everywhere and downed trees and piles of vegetation were common (Figs. 4F-H).

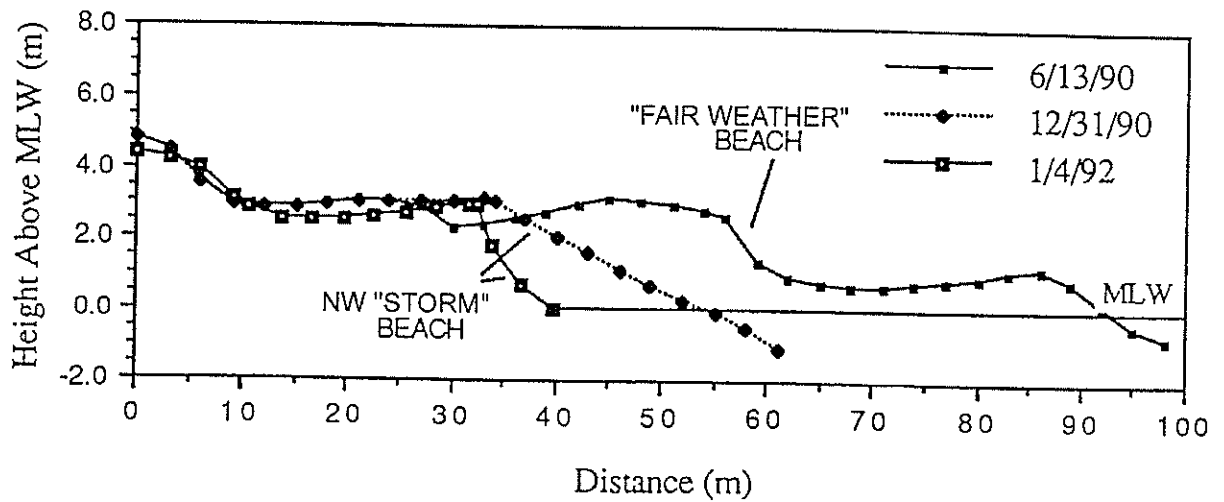
Figure 7 shows beach profiles made in the early 1990s at a monitoring station located immediately south of the Savio house (Station #3 of Loizeaux et al., 1993). These profiles clearly illustrate the dynamic nature of sand accretion and erosion on this

Figure 7. Data from Profile Station #3 of Loizeaux et al., 1993, located immediately to the south of the Savio house. These profiles reveal the dynamic nature of this section of beach, with sediment accretion under "fair weather" conditions generated by easterly Trade Winds versus erosion from the energy of northwest storm waves. Modified from Loizeaux et al. (1993).
