Recovery of Carbonate Sand Beaches on San Salvador Island, Bahamas From Damage by Hurricane Frances (2004)

**RECOVERY OF CARBONATE SAND BEACHES
ON SAN SALVADOR ISLAND, BAHAMAS
FROM DAMAGE BY HURRICANE FRANCES (2004)**

**Douglas W. Gamble & Pascal Kindler (eds.), 2012, *Proceedings of
the 15th Symposium on the Geology of the Bahamas
and Other Carbonate Regions:*
San Salvador, Gerace Research Centre, p. 1-14.**

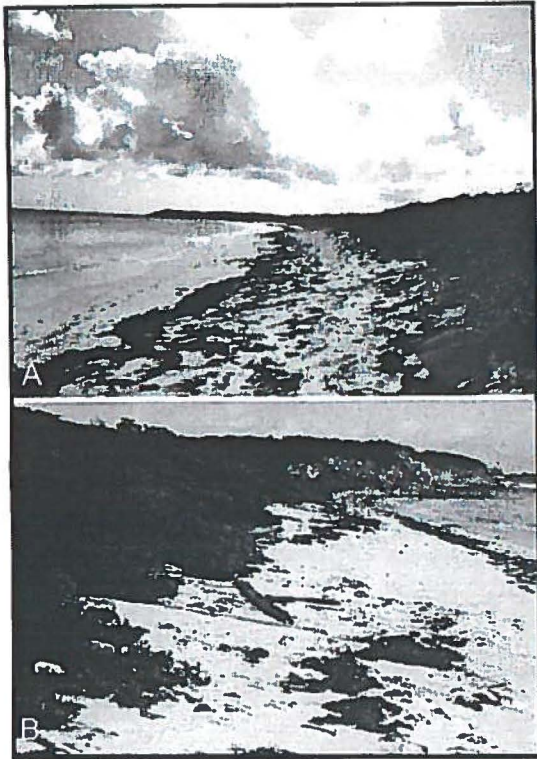
Figure 2. A) East Beach looking south toward Crab Cay from near Profile line 2. B) Hanna Bay Beach looking north toward the Hanna Bay cliffs from near Profile line 2.

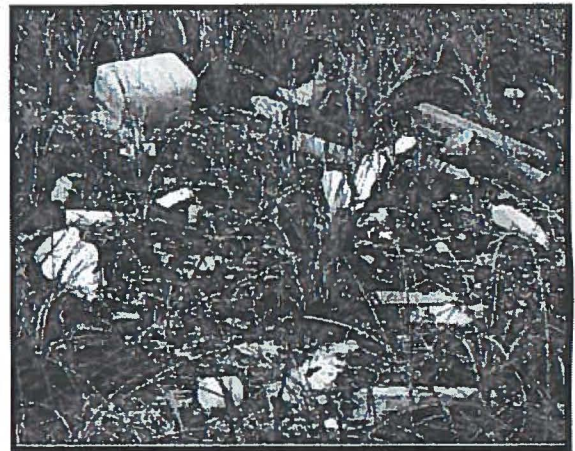
Figure 3. Anthropogenic debris washed into the dunes of East Beach by storms. Photo taken in January 2010.

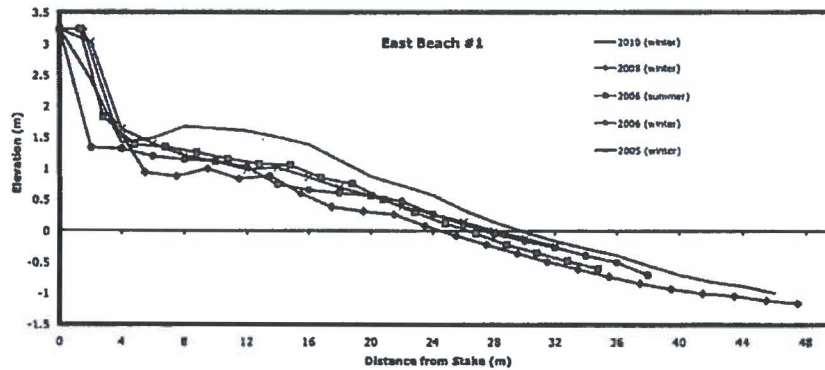
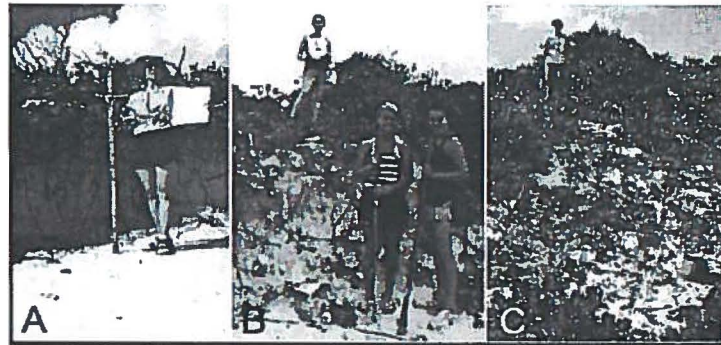
Figure 5. Top) Profiles from East Beach, Station 1. Photo views of the prominent scarp cut by Hurricane Frances; profile-origin stake is 1 m inland from scarp: A) January 2005; B) June 2006; C) January 2010.

East Beach 1 (Fig. 5): The prominent scarp cut by Hurricane Frances has remained the dominant feature at this location, even as it has softened with time (see Fig. 5 photo set). The 2010 profile documented development of an embryonic primary dune and significant sand deposition since 2008. The 2006 summer profile was almost identical to the winter profile of 2005. Opportunistic plants have advanced seaward, with the dominant species being *Uniola paniculata* and *Borrchia arborescens*.

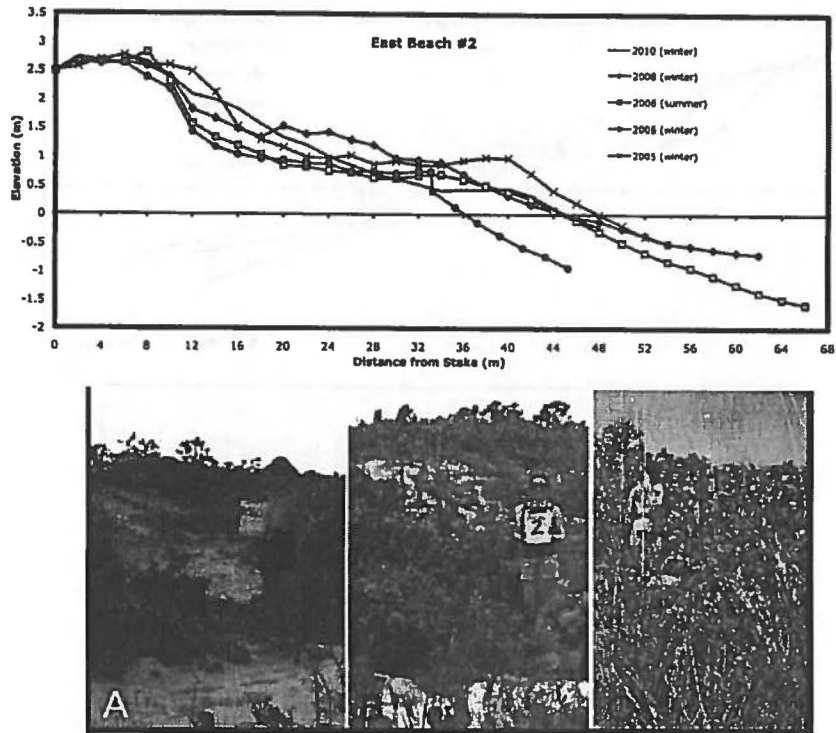
Figure 6. Top) Profiles from East Beach, Station 2, located immediately south of the access trail leading to the beach. Photo views looking inland and normal to the beach with profile team member standing adjacent or very close to the profile-origin stake: A) January 2005; B) June 2006; C) January 2010.

East Beach 2 (Fig. 6): This station is located immediately south of the juncture of the access trail to the beach. The 2010 profile displayed little morphologic variation compared with 2008 when a distinct trough and dunelet were present. Surprisingly, the summer 2006 profile showed more erosion than any of the winter profiles, documenting erosion from storm activity in the first half of 2006. Vegetation density increased substantially between January 2008 and January 2010 in the small overwash area where the profile stake is located (Fig. 6 photo set).

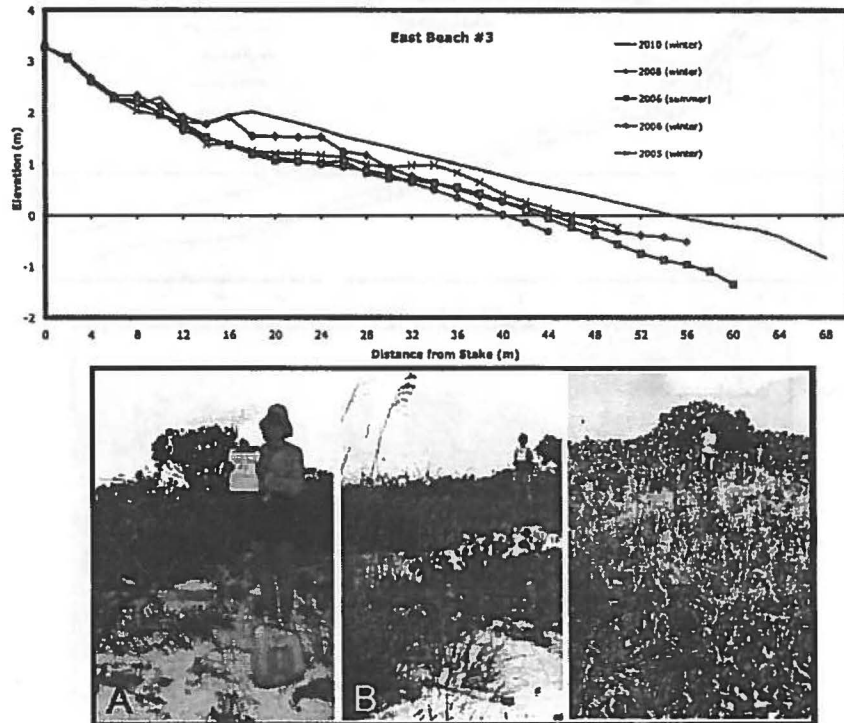
Figure 7. Top) Profiles from East Beach, Station 3. Photos oriented as previously: A) January 2005; B) June 2006; C) January 2010.

East Beach 3 (Fig. 7): Similar to East Beach 2, the 2006 summer profile also indicated erosion in the first half of 2006. The 2010 profile showed continued development of an embryonic primary dune that first appeared in 2008. This station and East Beach 4 have had significant sand accumulation since winter 2005. Vegetation has advanced, with the upper part of the backshore now densely covered by *Uniola paniculata* (sea oats; Fig. 7 photo set).

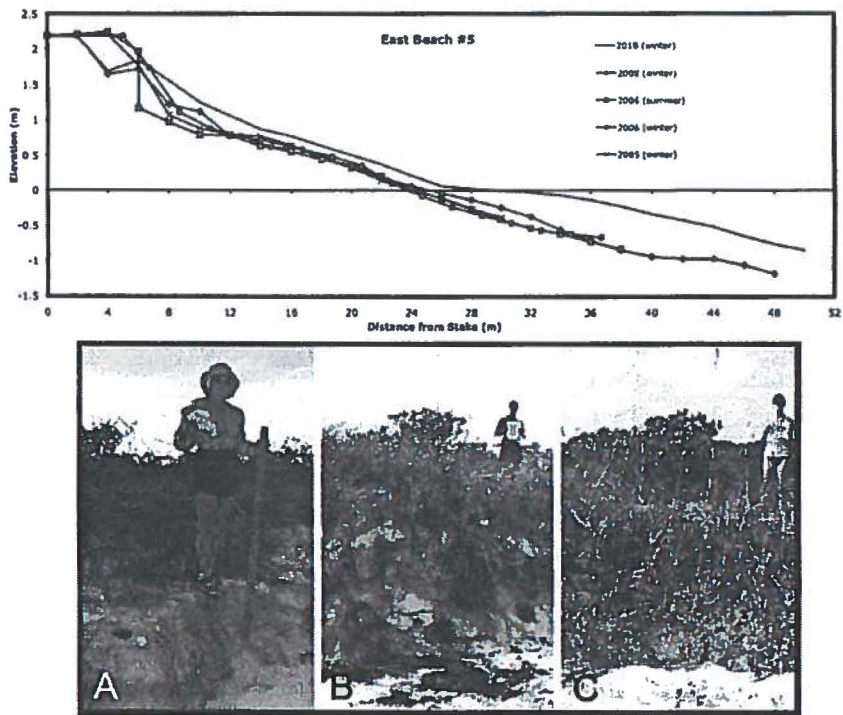
Figure 9. Top) Profiles from East Beach, Station 5, the southern-most study location. Photos oriented as previously: A) January 2005; B) June 2006; C) January 2010.

East Beach 5 (Fig. 9): The 2010 profile highlighted the continuous and fairly uniform increase in sediment since winter 2005 with softening of the scarp cut by Hurricane Frances in the front of the primary dune line. The subsea part of the 2010 profile indicates recent sediment progradation. A wide variety of plants were observed in this area, with the dense ground cover consisting mainly of *Ipomea pes-caprae* and *Lantana involucrata* (see Fig. 9 photo set).

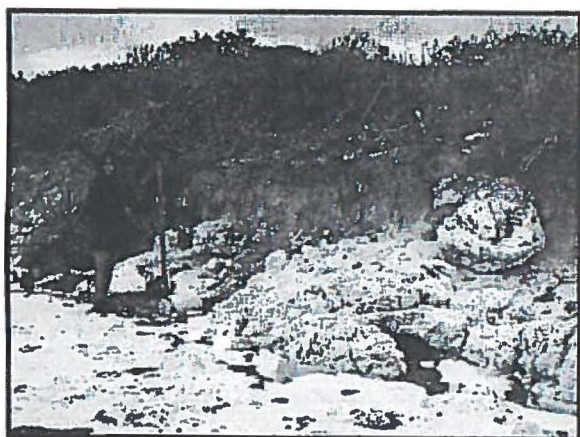
Figure 10. The severely eroded face of the primary dune at Hanna Bay Beach with exposure of underlying poorly lithified eolianite rock. Photo taken in January 2005.

This narrow and relatively short expanse of beach suffered severe erosion from Hurricane Frances. A prominent scarp was cut into the primary dune line on the full southern half of the beach. Along the northern half leading toward merger of the beach with the Hanna Bay cliffs, much sand was removed from the face of the primary dune, revealing the poorly lithified eolianite rock that lies below and behind the primary dune (Fig. 10). The extent and degree of solid lithification in the exposed beds at the back of the beach was somewhat of a surprise.
