Smith College Campus ADA Accessibility Report

By Lily Gould, Olivia Kraft, Allison Pasbjerg, and Mia Schildbach
Community Partner Project in Collaboration with the Smith College Botanic Garden

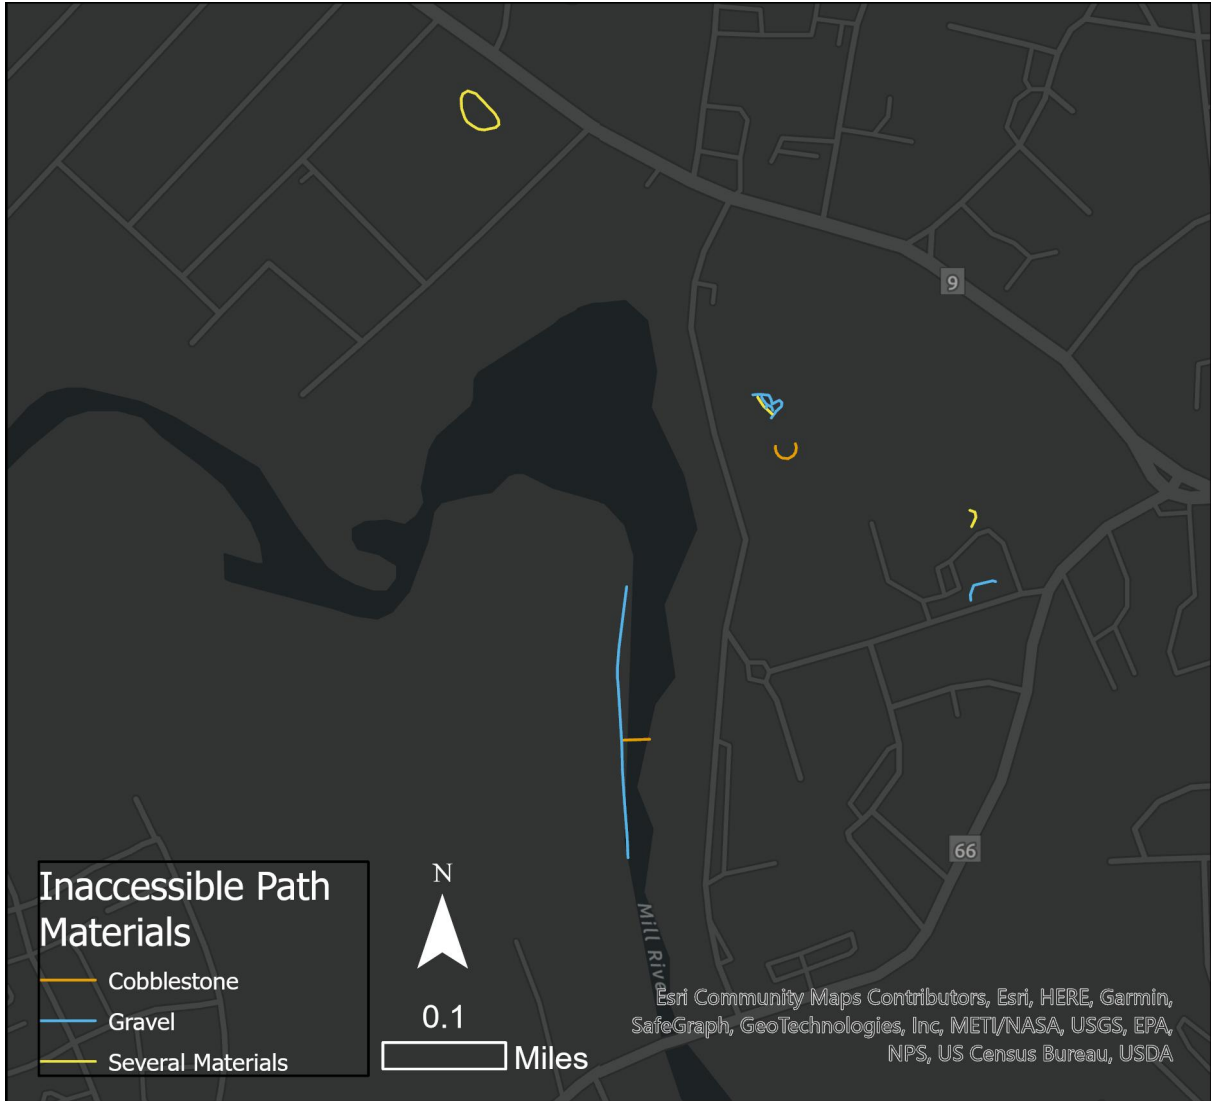
The second map (**Figure 3**) shows the materials deemed inaccessible, cobblestone and gravel. Importantly, there were other inaccessible materials listed in our initial FieldMaps survey, but because we did not encounter paths with these materials, they are not included in the legend.

Figure 2: A map displaying the paths documented on campus that were made out of inaccessible materials. Please note that because all campus paths are not shown, these areas appear disconnected. This is in an effort to highlight these few areas that are made from inaccessible materials. Paths made out of cobblestone are shown in orange, paths made out of gravel are shown in light blue, and paths made out of multiple different types of inaccessible materials are shown in yellow.

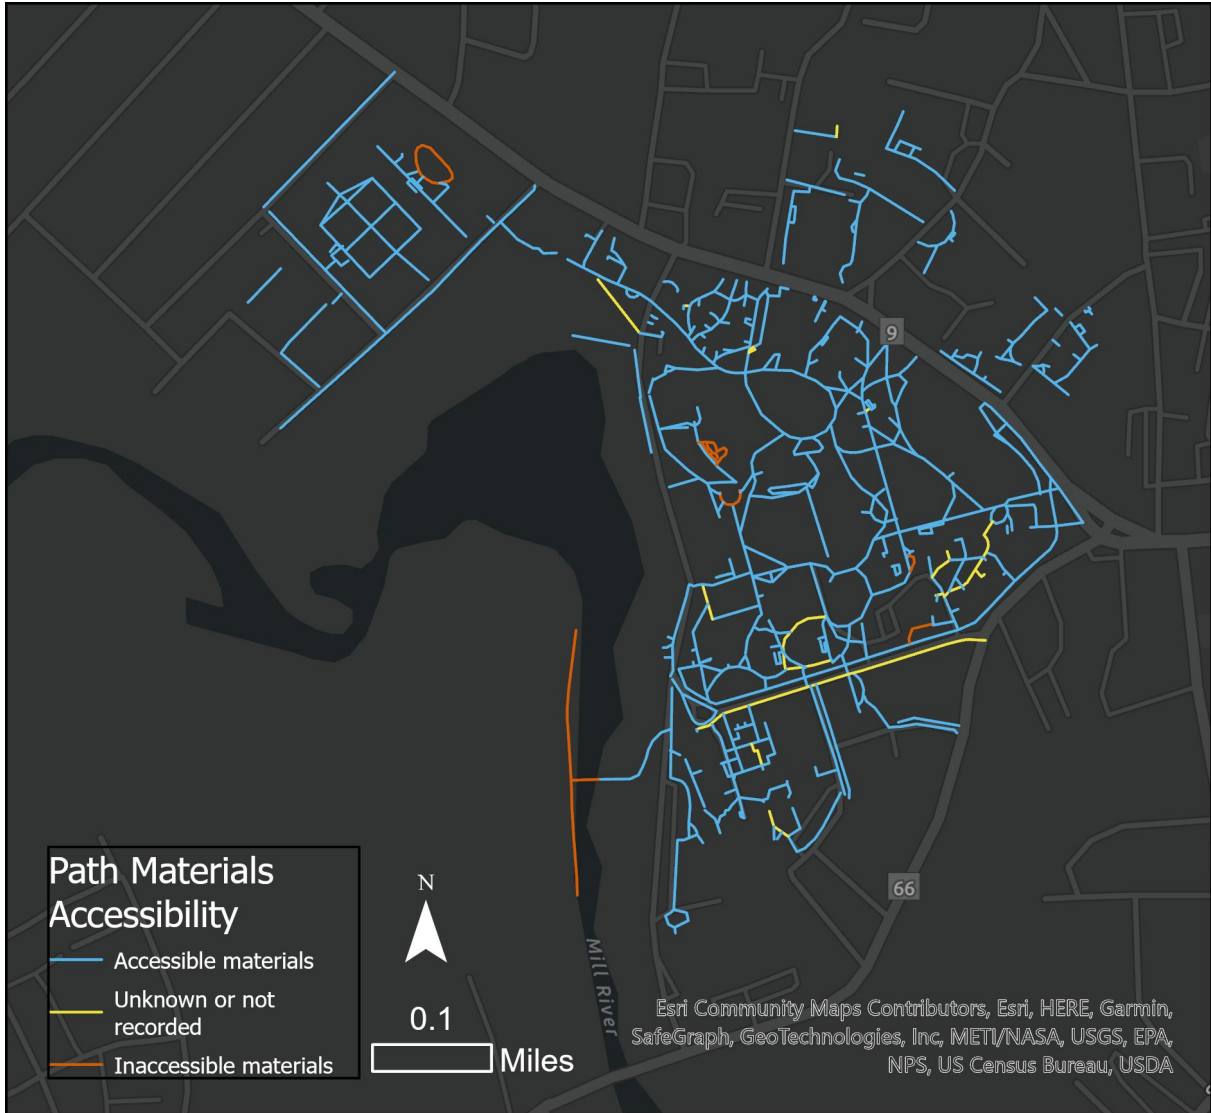
The last of the three maps (**Figure 4**) shows which paths were made of accessible materials and which paths were not. This map was created in order to show a summarized overview of areas on campus composed of inaccessible versus accessible materials. According to this map, most paths were made out of accessible materials.

Figure 4: A map documenting whether paths on campus are made out of accessible or inaccessible materials. Paths made out of accessible materials are shown in light blue, paths made out of inaccessible materials are shown in orange, and paths whose materials are unknown or not recorded are shown in yellow.

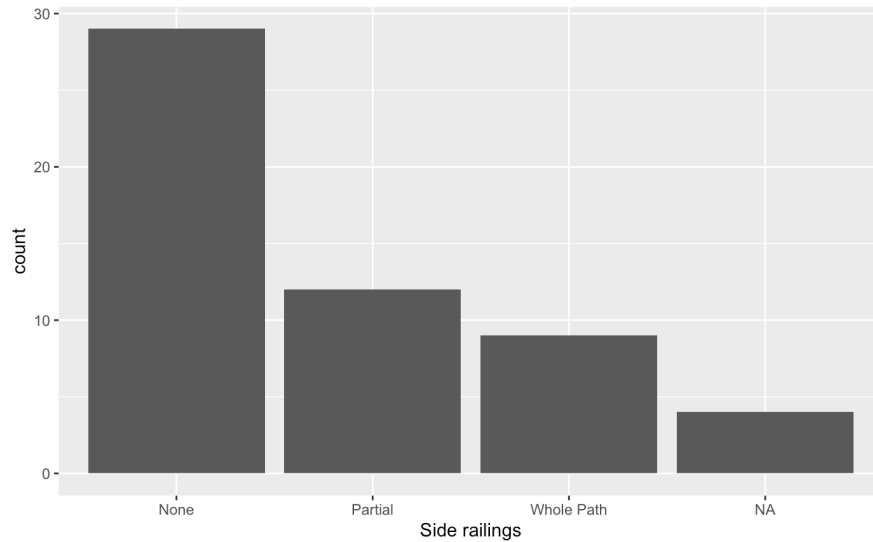
Figure 8: A bar chart showing the distribution of presence of side railings among the 54 ADA compliant ramps. 29 have no railing, 12 have a partial railing, and 9 have a railing along the whole path.

We extracted the accessible ramps, and determined the distribution of the presence of railing. This is summarized in the bar chart above (**Figure 8**).

It is clear that the many paths considered to be ramps do not have railings. This alone is not enough to determine the nature of this relationship, but it is worth exploring further. One recommendation for further study could be to overlay the slope map with a topographic map of Smith College campus, and examine where railings are not present and where they could be most needed. It would also make sense for further inquiry to look at the entrances of buildings in particular, as these are especially important areas for railing placement.

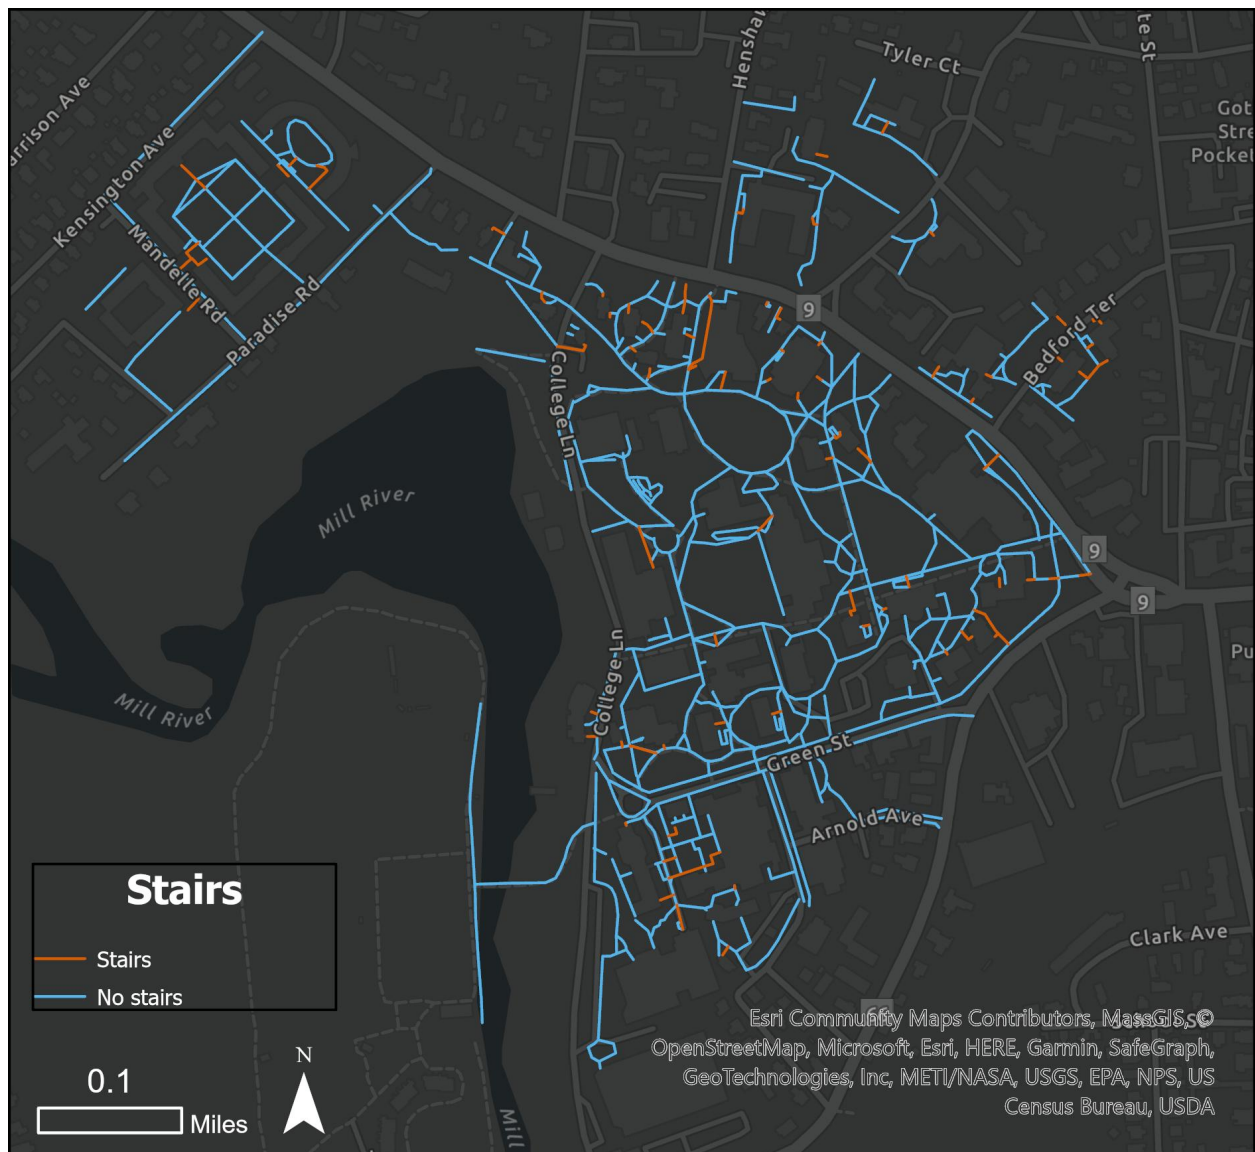
One of the most straightforward inaccessible features that a path can have is stairs. According to the ADA, an untreated level change of more than $\frac{1}{4}$ " is not permissible, and a level change with beveling to a 1:2 slope on the upper portion is permitted for elevation changes up to $\frac{1}{2}$ " ([U.S. Access Board, ADA §303](#)). In most cases, stairs will have vertical elevation changes on the order of a few inches, making them completely inaccessible to wheelchair users. Of the paths that we took data on, 78 of them had stairs. These were most common at building entrances—notably, almost every building had alternative, accessible entrances that could be used instead of the stairs, so even though this seems like a large number of paths, there are very few instances where traversing stairs would be required for entry.

Figure 12: A map showing which paths have stairs (orange) and which do not (blue) of the paths we took data for.
